Florida Department of Transportation Research Damage Detection and Repair Methods for GFRP Bridge Decks BDK75 977-17

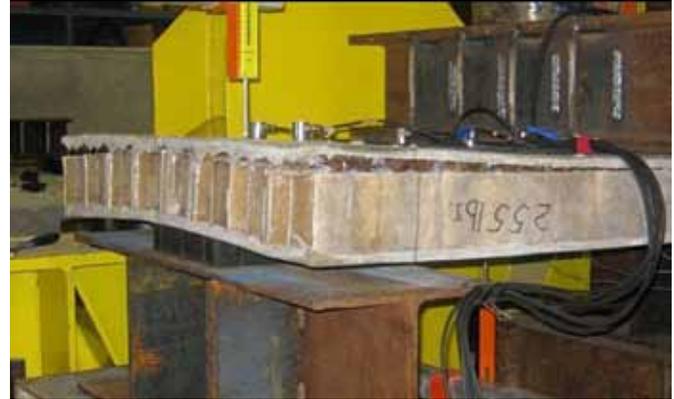
A section of GFRP deck is loaded to failure in a laboratory setup.

Three commercial GFRP bridge decks were tested in both positive and negative bending in a three-point loading setup. Each specimen was subjected to sequential load tests consisting of service, ultimate, then service. Load steps were separated by a brief load reduction to allow observation of Kaiser and felicity effects during reloading. Two AE analysis methods, intensity analysis and relative ratio analysis, were used to evaluate the data. Intensity analysis did not provide sufficient discrimination between damaged and undamaged states, but relative ratio analysis provided sufficient discrimination to allow development of criteria for laboratory testing. A modified form of relative ratio analysis was also used to analyze selected AE data from a bridge load test.
