Evaluation Guide – Pedestrian Longitudinal Channelizing Devices (LCDs)

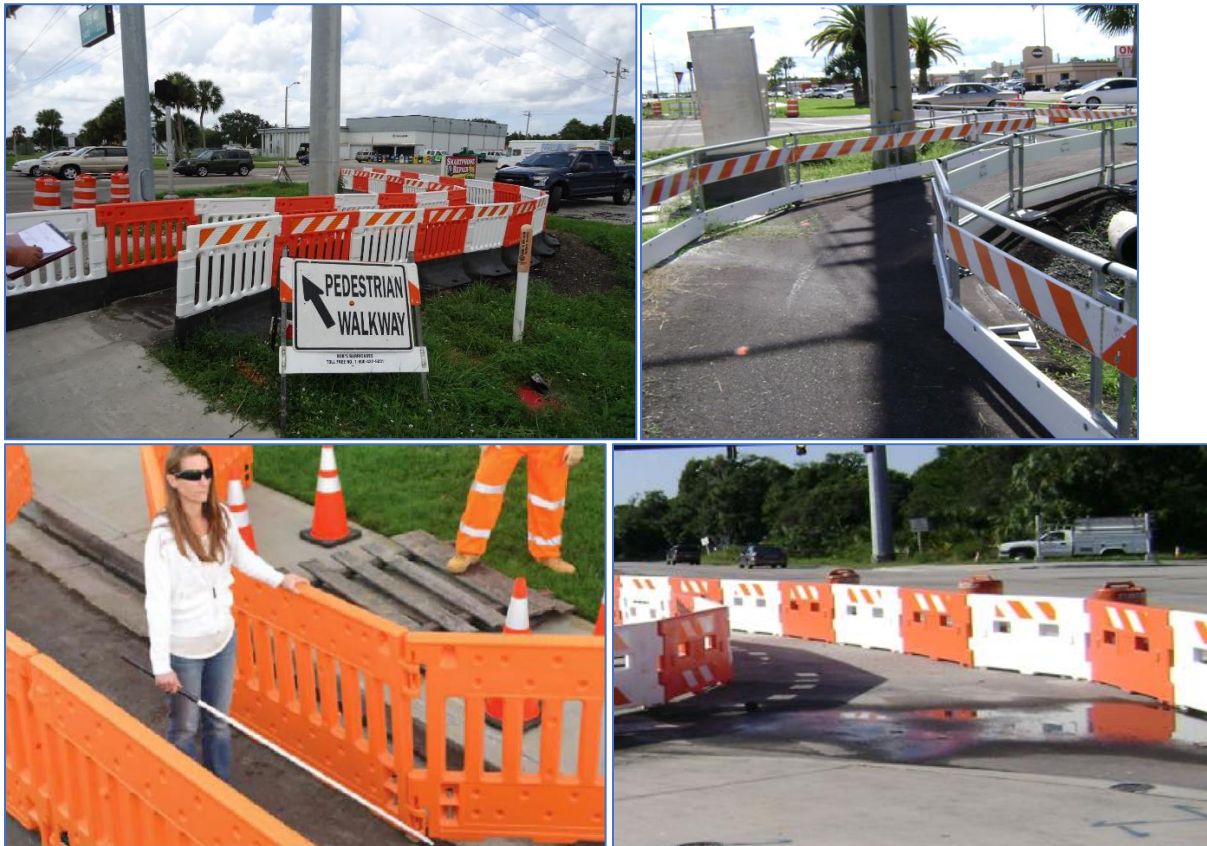
Acceptable

To be considered acceptable, a channelizing device shall meet all of the following conditions:

- The devices' shape should remain clearly identifiable with no significant distortion and shall be free standing in its normal position.
- Surface is free of punctures and abrasions.
- Surface is free of asphalt splatter, cement slurry, dirt or other material and will readily respond to washing.
- When devices are required to be interlocked, all connection hardware is intact providing a continuous detectable edge and secured fit between devices.
- Ballasting hardware and other related attachments are intact providing proper stability

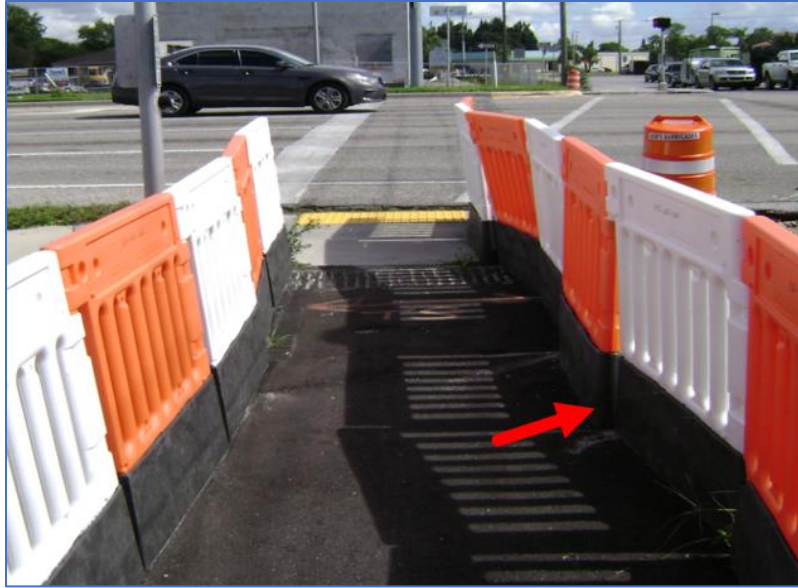
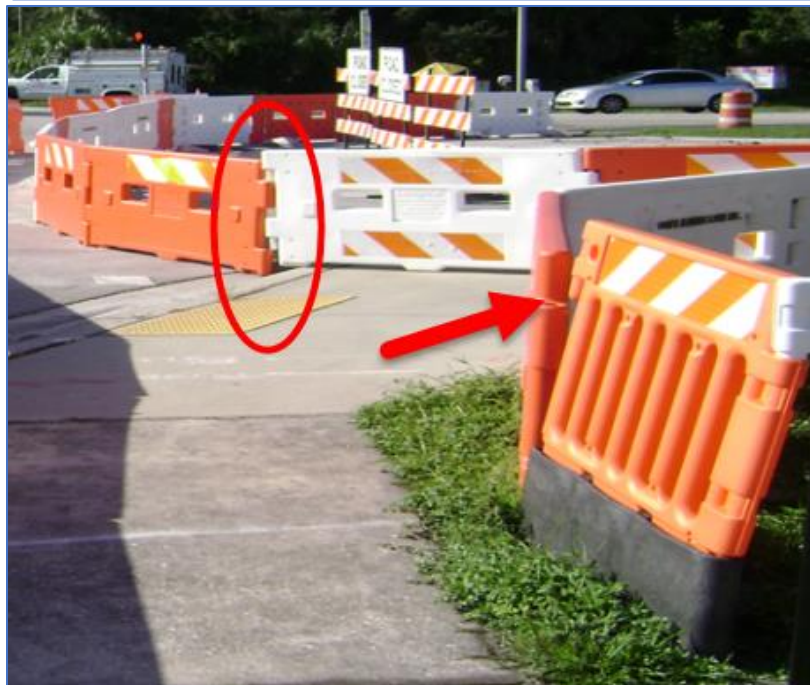
Marginal

The channelizing device is considered marginal, if it meets any of the following conditions:

- The surface has some asphalt splattering, cement slurry, dirt and may not be readily cleaned.
- The surface has minimal abrasions or punctures with minor discoloration.
- When devices are required to be interlocked, a majority of the connection hardware is intact but still providing continuous detectable edging
- A majority of the ballasting hardware and other related attachments are intact providing stability

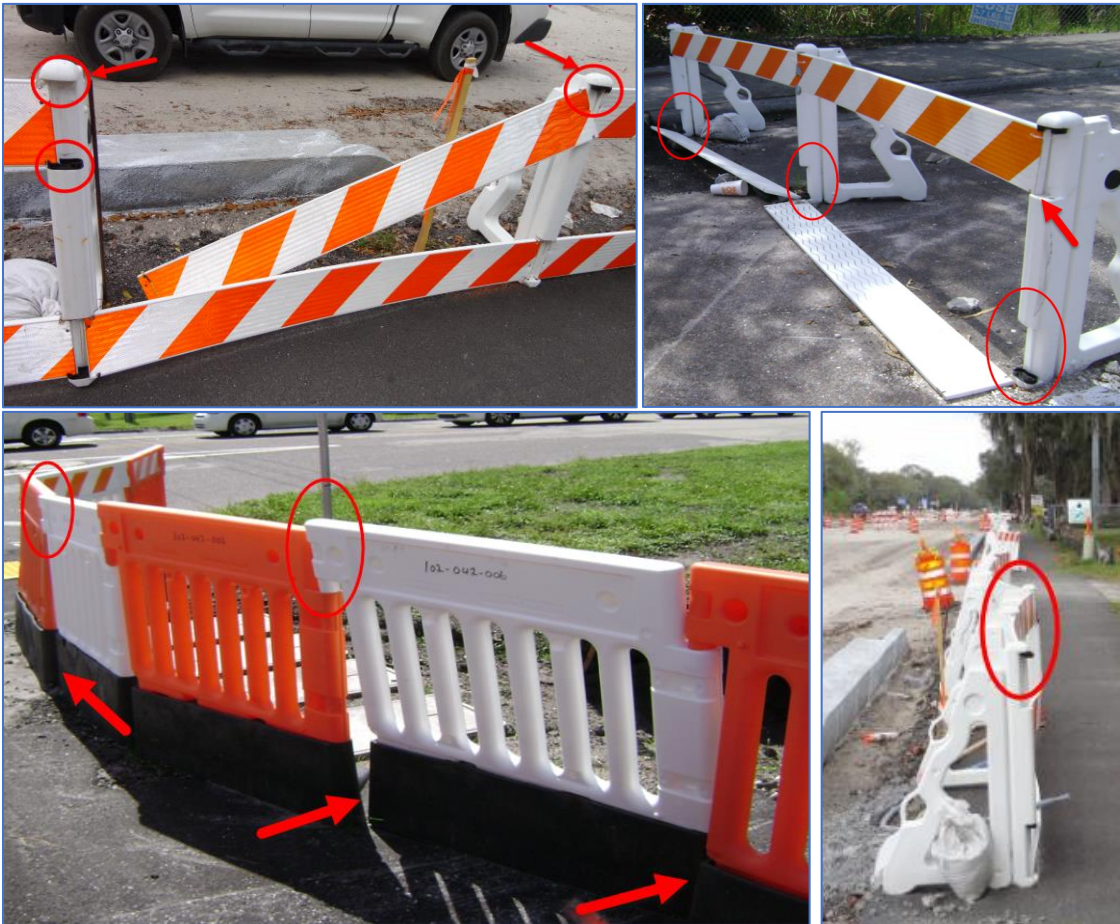
Unacceptable

A channelizing device is considered unacceptable if it meets any of the following conditions:

- Punctures and large areas of staining asphalt splatter, cement slurry or dirt that cannot be cleaned due to abrasions or discoloration.
- The surface has several punctures or abrasions with noticeable fading of the device's color.
- When devices are required to be interlocked, the connection hardware is not intact and unable to provide continuous detectable edging.
- The ballasting hardware and other related attachments are not intact with little to no stability.

- Substantial deformation of a device and loss of the intended shape.
