Florida Department of Transportation Research

Key Royale Bridge Five-Year Evaluation

BDK75 977-52

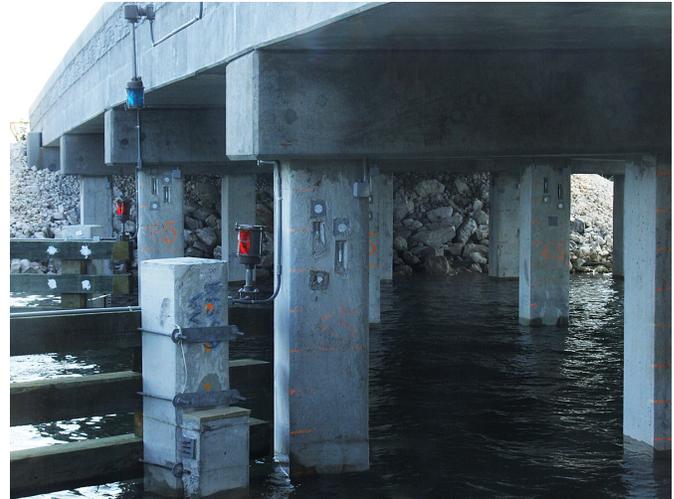
Bridge and fender piles of the Key Royale bridge are marked with access points of embedded instruments.
