**Moving the Bus Back Into Traffic Safely –
Signage and Lighting Configuration Phase I**

Final Report

November 2007

Florida Department of Transportation
BD 549-34

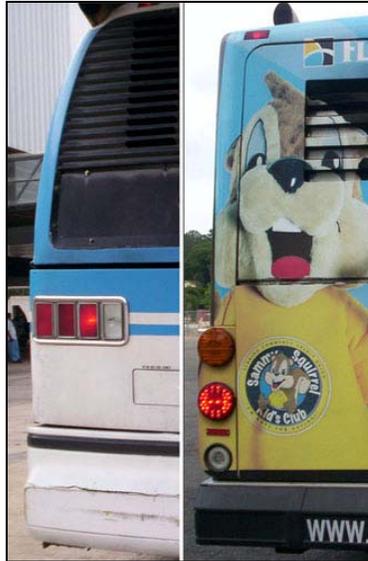
Figure 1 Vertical and Horizontal Light Configurations

The exact placement of these lights and markers vary by bus make and model. The lights are sometimes placed low on the bus close to the bumper, other times they are placed higher up. Lights may be aligned vertically or horizontally as shown in Figure 1, as long as they are located at the corner of the bus.

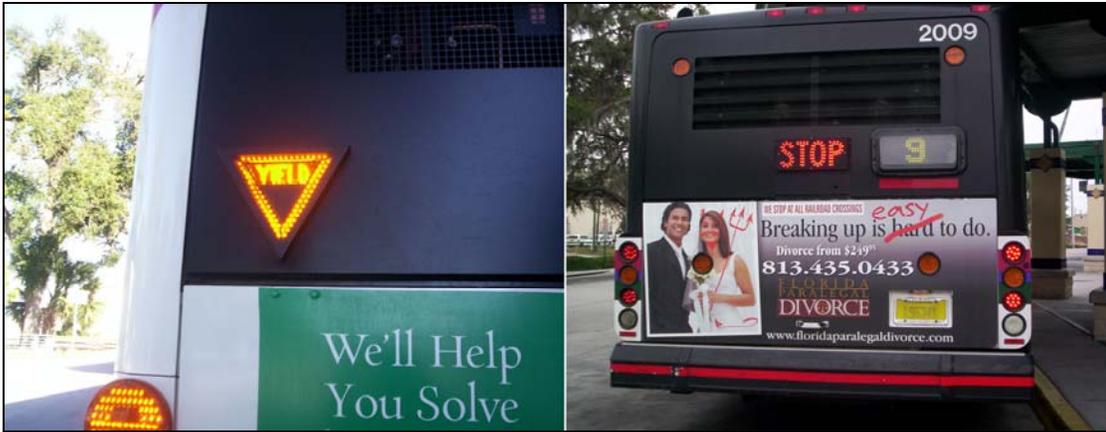
Figure 2 YIELD and STOP LED Lights

Additional light emitting diode (LED) lights and deceleration lights are sometimes added to improve bus safety. Options available in LED lights include lights that spell the word STOP and YIELD (Figure 2). Transit agencies may also change the positions of amber and red lights and increase the size of the lights. Reflective tape is also used to increase the conspicuity of buses. Other lighting used to improve the conspicuity of the bus includes daytime running lights, additional lights around the bus, and strobe lights. LED lights have additional benefits as they are said to have a useful life approximately 100 times greater than incandescent bulbs. Incandescent lights have been traditionally used for the external lighting on buses.

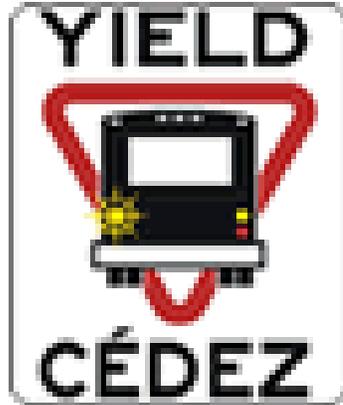
Figure 4 Yield/Cédez Decal in Canada

In 2004, Ontario, Canada passed a Yield-to-Bus law similar to the ones in the U.S. The new law applies to all buses that bear the YIELD / CÉDEZ decal (Figure 4) near the left turn signal on the rear of the bus. When a bus displaying the sign is signaling its intention to leave a bus bay by activating the left turn signal, drivers approaching from the rear in the adjacent lane are required to slow down or stop to allow the bus to re-enter the lane, unless it is unsafe to do so.

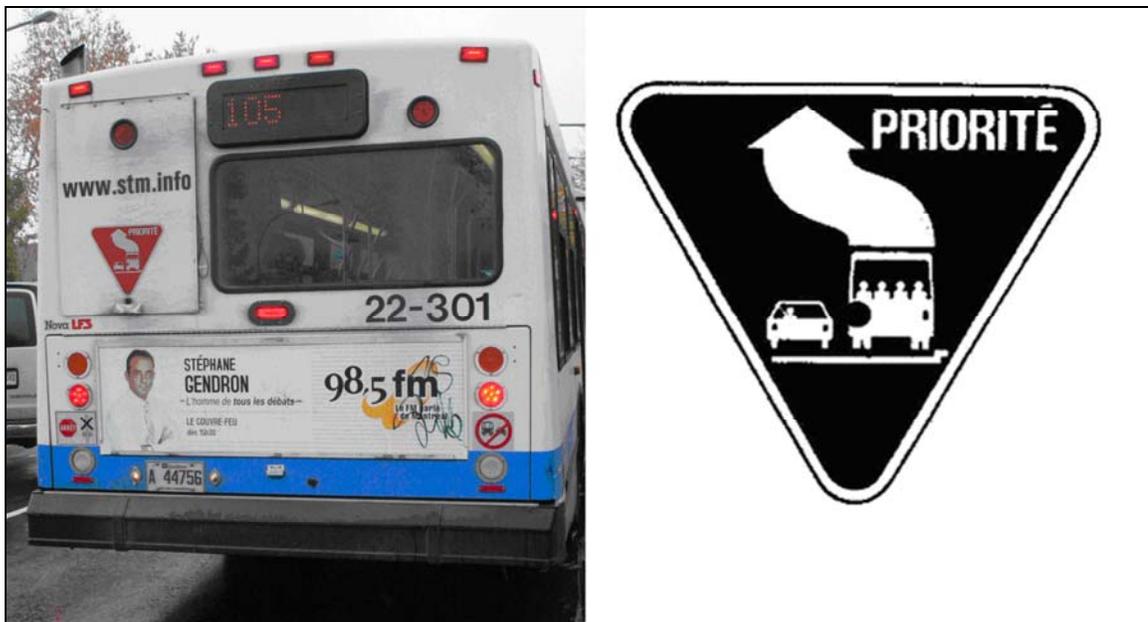
Figure 5 Bus Priority Sign in Canada

Yield-to-Bus legislation has been in effect in Quebec since 1982. The law was drafted similar to the European laws. A decal is placed on the lower-left corner of the rear window of the bus. The decal consists of an inverted equilateral triangle with sides 38 cm and a red message on a white back ground (Figure 5).

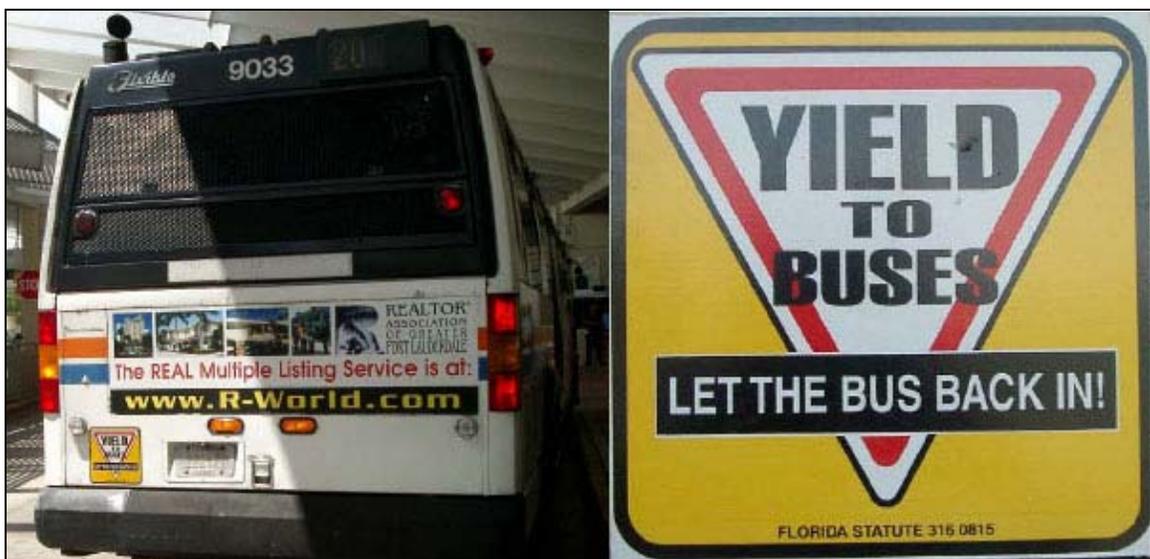
Figure 6 YTB Decal 1 (Broward County Transit)

As shown in Figure 6, Broward County Transit (BCT) uses a reflective Yield-to-Bus (YTB) decal on the lower-left rear corner above the bumper of the bus. The decal is an equilateral triangle with sides approximately 18 inches in length. The triangle is red on a yellow background with white words on a black background. BCT also considered using an electronic flashing yield sign but they were concerned with electrical power load.

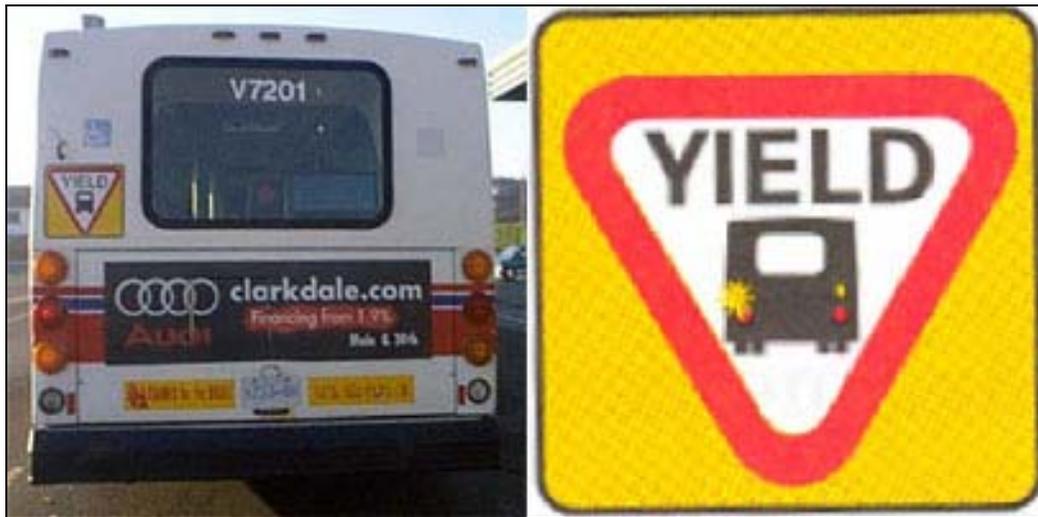
Figure 9 YTB decal 2 (Coast Mountain Bus Company)
(Source: TCRP Synthesis 49)

As shown in Figure 9, Coast Mountain Bus Company (CMBC) uses a reflective square decal with sides approximately 10 inches in length. Inside the square is a red equilateral triangle on a yellow background. Inside the triangle is white with “Yield” written in black letters and the silhouette of a bus below it. The decal is located to the left of the rear window on the back of the bus. A decal was chosen over the electronic yield sign because the decal was significantly less expensive. However, some CMBC buses that operate in West Vancouver use the LED yield sign in combination with the decal. On the rear bumper, CMBC also includes a YTB-related decal signs that say “Thanks for the Brake” and “Please Yield it’s the Law”, as shown in Figure 10.

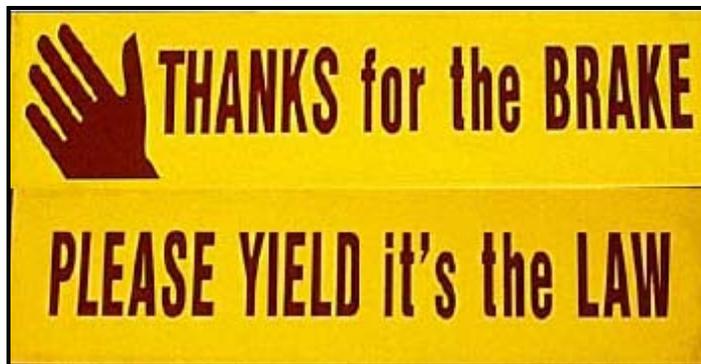
Figure 10 YTB-related decal signs by CMBC
(Source: TCRP Synthesis 49)

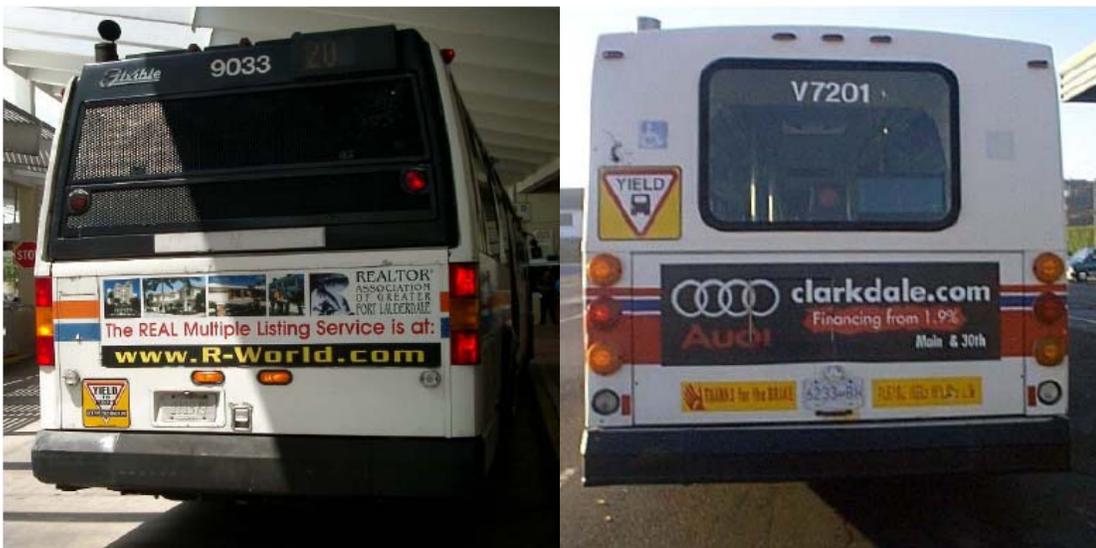
Decal 1

Decal 1 and Decal 2 are very similar, except for the location of each decal on the back of bus. Decal 1 is installed just above the bumper, and Decal 2 is installed at half way up and to the left side on the rear of the bus, as shown in Figure 15.

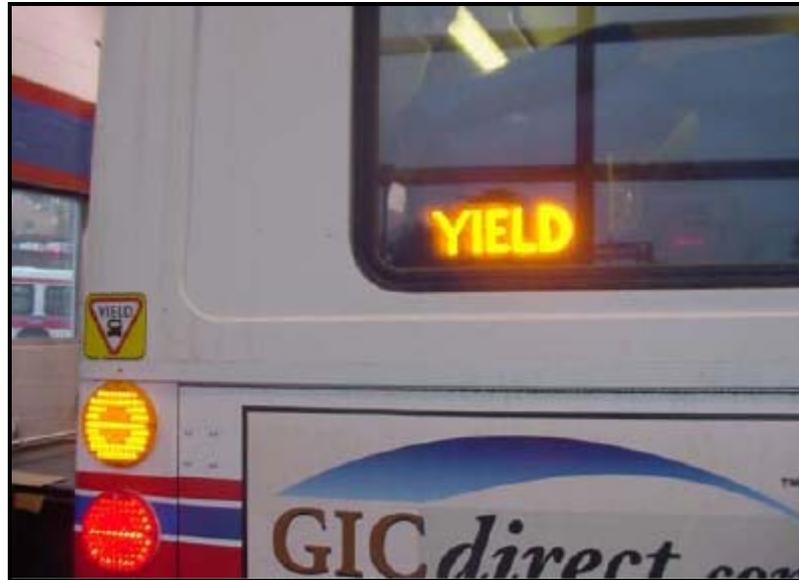
Figure 18 British Columbia Transit YTB decal and Yield LED Sign
(Source: TCRP Synthesis 49)

British Columbia (BC) Transit uses a six inch square reflective yield decal and a LED yield sign as shown in Figure 18. Inside the square is a red equilateral triangle on a yellow background. Inside the triangle is white with “Yield” written in black letters and the silhouette of a below it. This decal is used throughout British Columbia and is similar to the CMBC decal. The LED yield sign is located in the lower-left corner of the rear window.

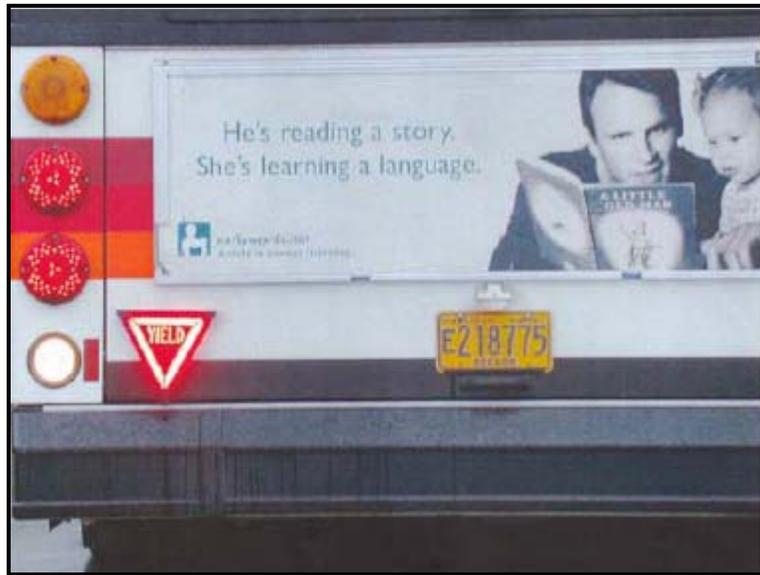
Figure 19 Tri-Met LED Yield sign
 (Source: TCRP Synthesis 49)

In Oregon, specifications have been developed by the Oregon Transportation Commission for a yield sign that includes a 6.75 inch tall triangle with the word “Yield” inside. Both the triangle and yield message must be red when flashing. Tri-County Metropolitan Transportation District (Tri-Met) uses a red LED flashing yield sign with a triangle that is approximately eight inches on each side as shown in Figure 19. The flashing yield sign is located on the lower-left corner above the bumper. A control switch is used by the bus operator to activate the yield sign. The operator first activates the amber turn signal then the yield sign. The yield sign is deactivated when the left turn signal switch is released.

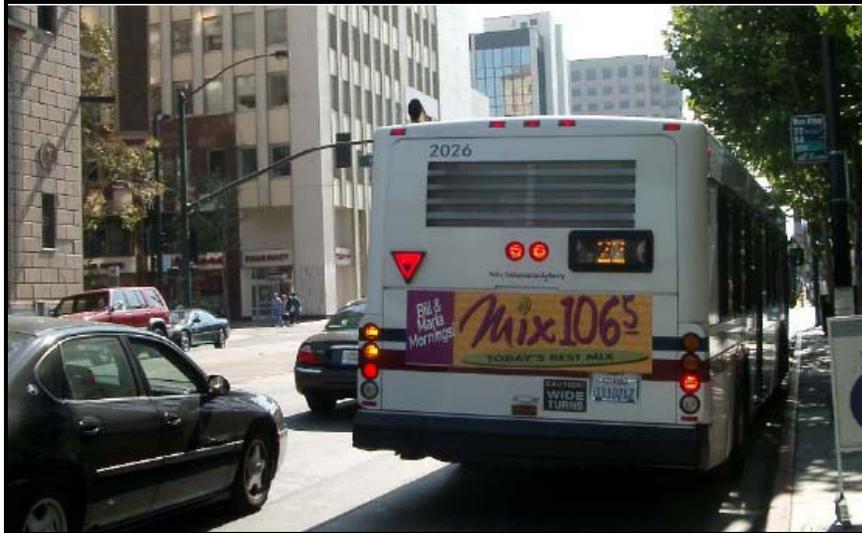
Figure 22 Santa Clara Valley Transportation Authority Bus with LED Yield Sign
(Source: TCRP Synthesis 49)

California law requires that buses be equipped with a yield right-of-way sign on the left rear of the bus. The sign must be illuminated by a flashing light when the bus is signaling to enter a traffic lane. The Santa Clara Valley Transportation Authority and the Santa Cruz Metropolitan Transit District use the same flashing yield sign as Oregon, mounted on the rear left of the bus above the engine access door as shown in Figures 22 and 23. The yield sign is activated first, followed by the left turn signal and both signals will stop when the left turn signal is turned off. Arming the yield signal first allows the bus operator to have both hands on the steering wheel when pulling out from a stop. After 10 to 15 seconds, the yield sign deactivates; therefore, if the operator cannot move before then, the left turn signal must be released and the yield control button pushed again.

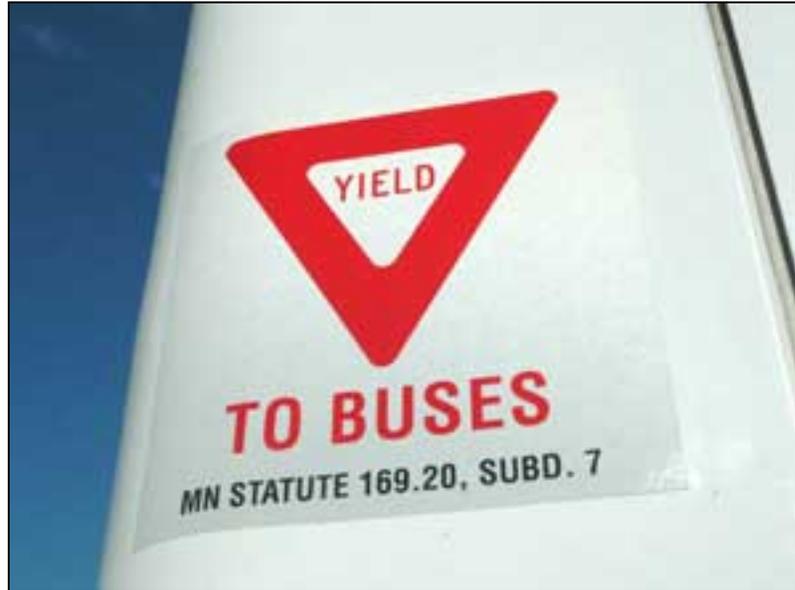
Figure 26 Metro Transit Decal

The Metro Transit decals feature a red yield sign along with a reference to the Minnesota statute that gives buses priority as shown in Figure 26. The decals are being positioned on the left side and above the brake lights for maximum visibility. These decals have only recently been developed even though the law requiring motorists to yield to the bus has been around for many years.

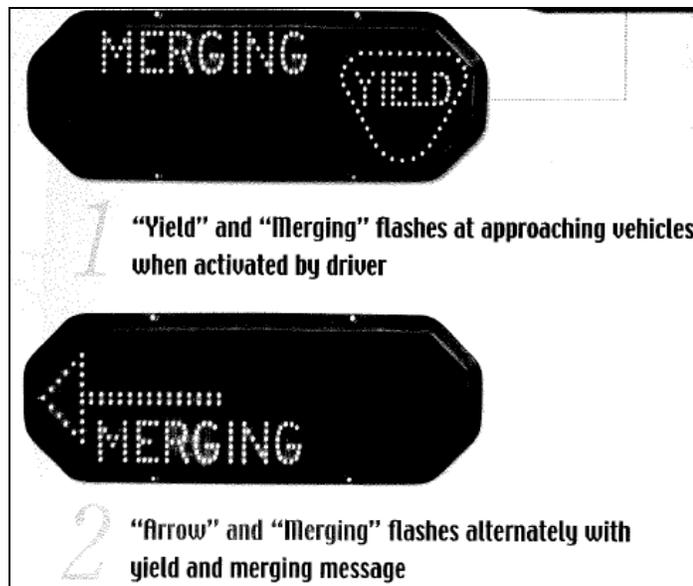
Figure 30 Transpec Merge Alert LED Sign

Other signage directly related to YTB programs includes light emitting diode (LED) signs. These LED signs generally consist of a flashing “YIELD” sign activated by the bus operator when he or she attempts to re-enter the traffic lane. In 2006, Transpec Worldwide introduced a new LED flashing sign for the YTB programs. The new Transpec Merge Alert motorist warning device has been developed to assist with motorist education of YTB laws. The merge Alert delivers a highly-visible, high-brightness LED message that the bus is merging back into traffic. The device flashes a "Yield" sign, along with the word "MERGING," and then alternates to a flashing, left pointing "ARROW" along with a second "MERGING" text (Figure 30). In transit operations tests, the Merge Alert significantly reduces difficulty in the bus reentering traffic and reducing rear-end collisions.

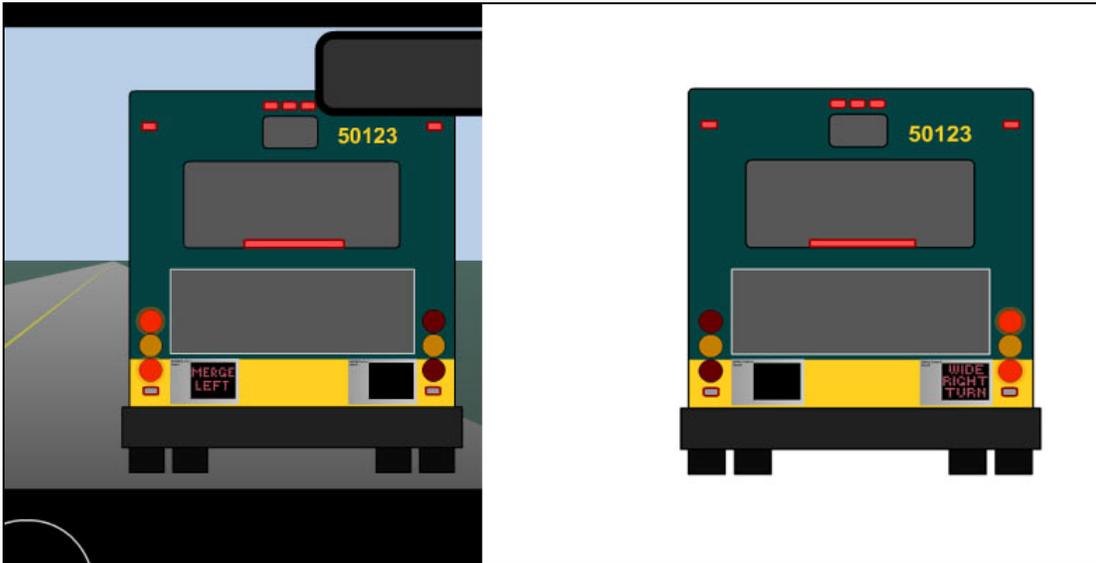
Figure 31 Advanced Safety Wheel and Hubs Alert System

“Wide-Right Turn”, then strolling arrows pointing right. A “Thank You” message appears when the turn signal is turned off.

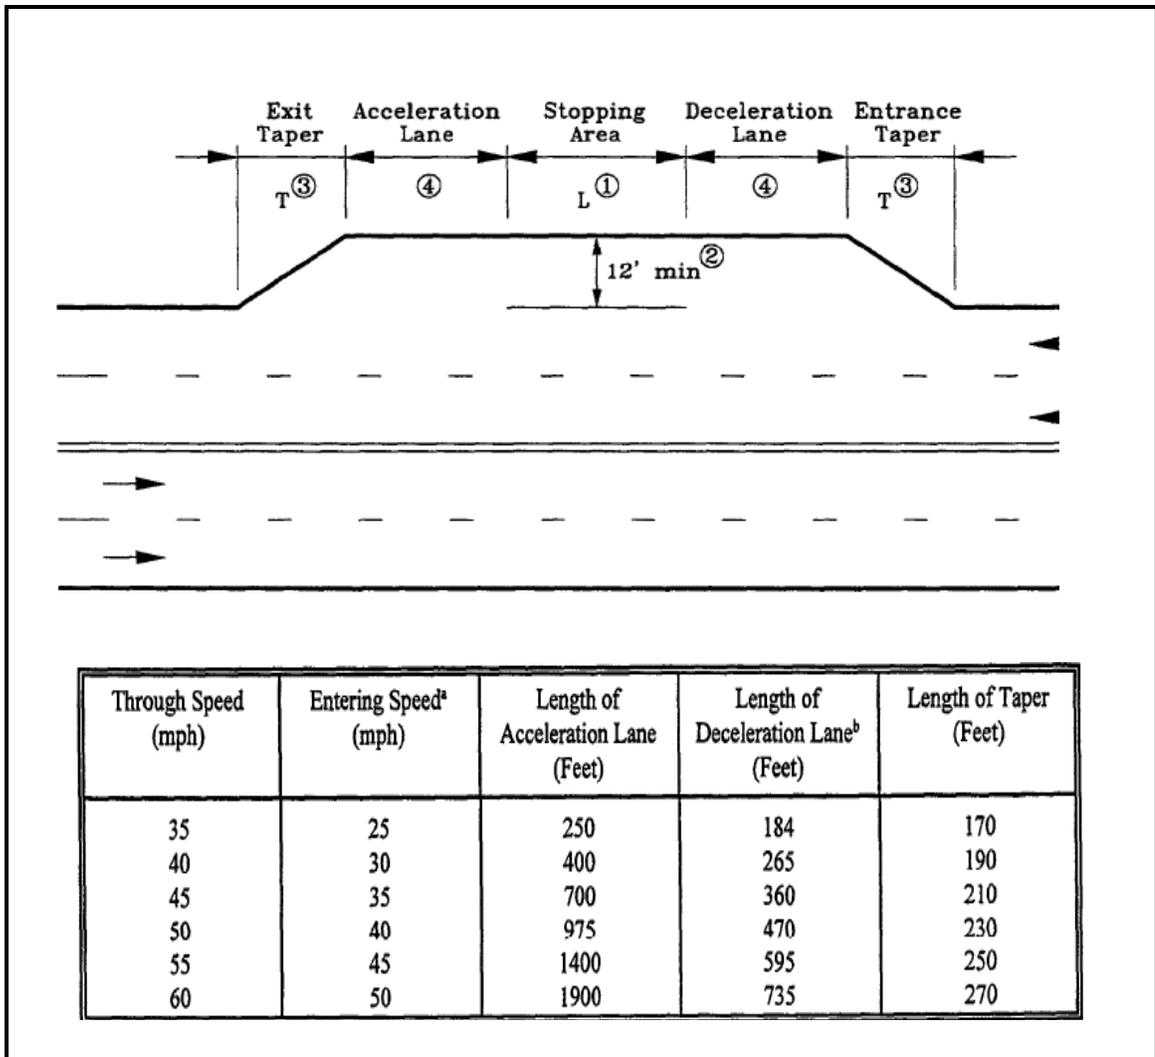
Figure 32 Bus Bay Configuration

TCRP Report 19: Guidelines for the Location and Design of Bus Stops contains information about the factors that would lead to the construction of bus bays. Bus bays should be considered on roads where curb lane traffic exceeds 250 vehicles during the peak hour, but bus drivers should not use bus bays when traffic volumes exceed 1000 vehicles per hour per lane (Texas Transportation Institute 1996). Heavy volumes make it very difficult for buses to merge back into the flow of traffic. Acceleration lanes, signal priority, or far-side placements are potential solutions for this. Bus bays are ideal where traffic speeds exceed 40 miles per hour, where vehicles are prone to collide with the rear-end of a stopped bus and locations with high passenger volumes or where the dwell time exceeds 30-seconds during peak hours. Areas where there are extended layover times and high volumes of buses at peak hours are also ideal for bus bays. Bus bays should be designed to reduce automobile-bus conflict, provide greater separation between traffic and pedestrians waiting for the bus, and allow the bus to quickly regain its travel speed upon re-entry into the traffic (Florida Planning and Development Lab 2004). As shown in Figure 32, the total length of a bus bay consists of an entrance taper, deceleration length, stopping area, acceleration length, and an exit taper.

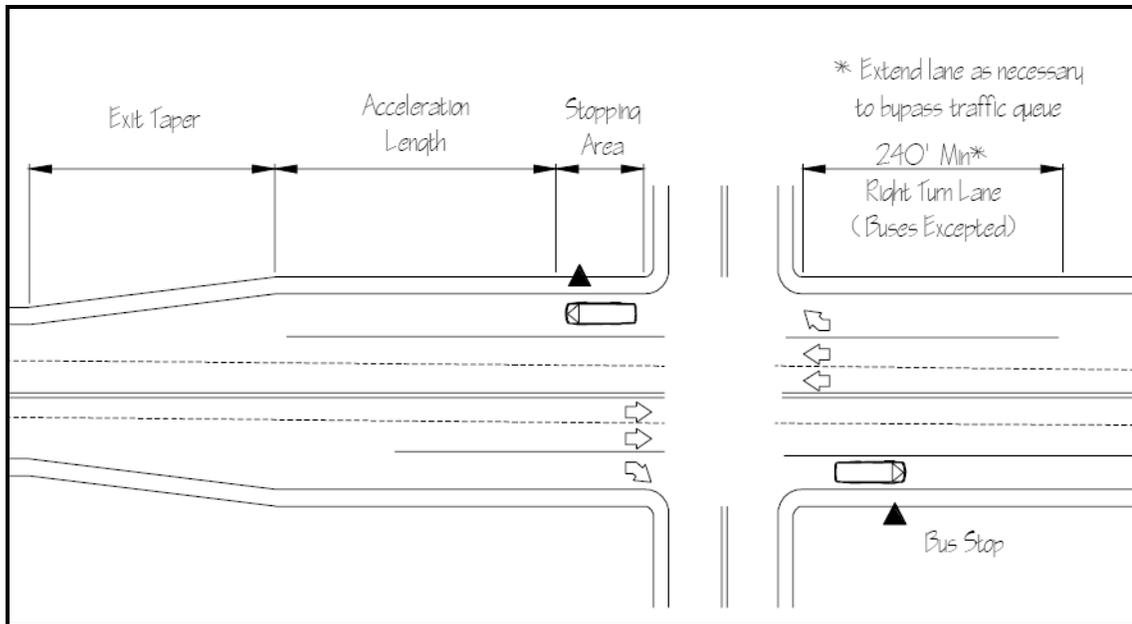
Figure 33 Queue Jumper Bus Bay Configuration

Another bus bay configuration is the queue jumper bus bay as shown in Figure 33. The queue jumper bus bay can be used in combination with a right-turn-only lane or at traffic signals that allow buses to move ahead of other vehicles. The queue jumper bus bay; however, may cause delays to right-turning vehicles. When designed with a right-turn lane, buses are allowed to use the right turn lane at the near-side of the intersection to bypass traffic congestion and move ahead to the bus stop located at the far-side of the intersection.

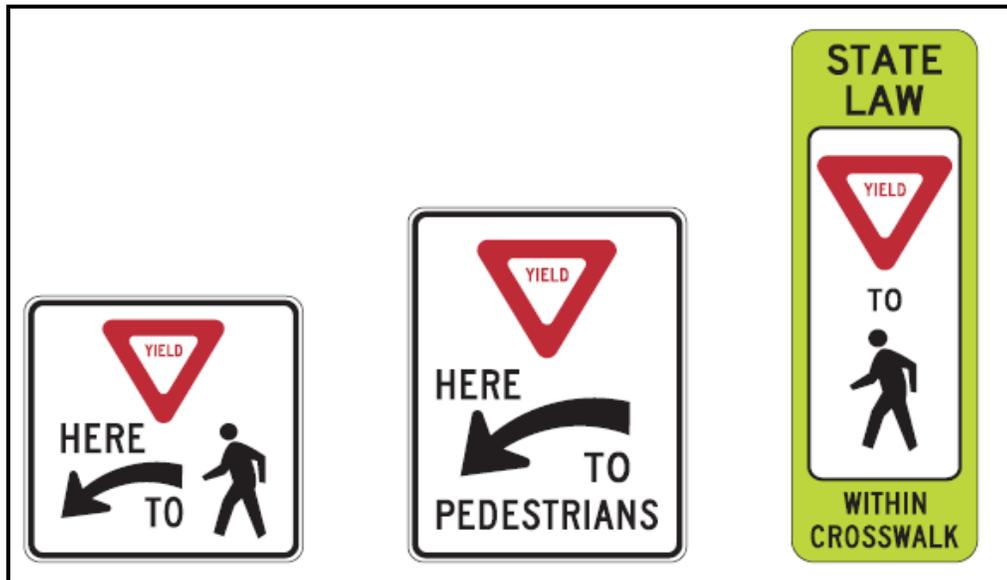
Figure 35 Yield to Pedestrians Signs (Source: MUTCD, 2B.13)

Vehicles controlled by a yield sign need to slow down or stop when necessary to avoid interfering with conflicting traffic. The MUTCD states that the yield sign assigns right-of-way to traffic on certain approaches to an intersection. It makes no mention of using yield-to-bus signs, but they do have special yield signs for yielding to pedestrians. If yield lines are used in advance of an unsignalized, marked midblock crosswalk, “Yield Here to Pedestrians” signs should be placed 6.1 to 15 m (20 to 50 ft) in advance of the nearest crosswalk line. The “In-Street Pedestrian Crossing” sign may be used to remind road users of laws regarding right of way at an unsignalized pedestrian crossing. The legend “State Law” may be shown at the top of the sign if applicable. The legends “Stop for” or “Yield to” may be used in conjunction with the appropriate symbol. Yield lines may be used to indicate the point behind which vehicles are required to yield in compliance with a “Yield” sign or a “Yield Here to Pedestrians” sign as shown in Figure 35.

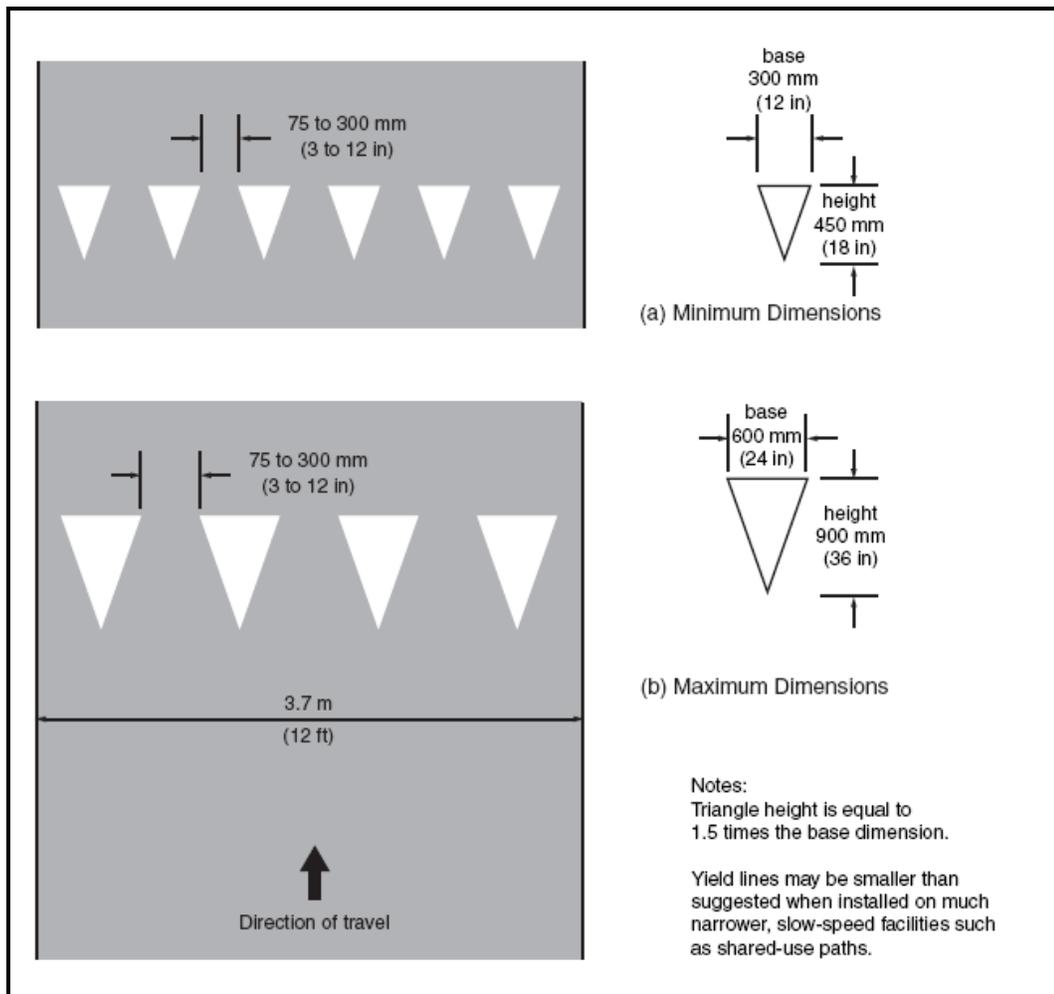
Figure 36 Yield Pavement Markings
 (Source: MUTCD, 3B.16)

The yield line consists of individual triangles with a base of 300 to 600 mm (12 to 24 in) wide and a height equal to 1.5 times the base. The space between the triangles should be 75 to 300 mm (3 to 12 in). Yield lines may be used to indicate the point behind which vehicles are required to yield in compliance with a yield sign (Figure 34) or a “Yield Here to Pedestrians” (Figure 35) sign. Yield lines are placed a minimum of 1.2 m (4 ft) in advance of the nearest crosswalk line at controlled intersections, except for yield lines at roundabout intersections and at midblock crosswalks. In the absence of a marked crosswalk, the stop line or yield line is placed at the desired stopping or yielding point, but should be placed no more than 9 m (30 ft) nor less than 1.2 m (4 ft) from the nearest edge of the intersecting traveled way. If used at an unsignalized midblock crosswalk, yield lines are placed adjacent to the “Yield Here to Pedestrians” sign located 6.1 to 15 m (20 to 50 ft) in advance of the nearest crosswalk line, and parking should be prohibited in the area between the yield line and the crosswalk as shown in Figures 36 and 37. Drivers who yield too close to crosswalks on multi-lane approaches place pedestrians at risk by blocking other drivers’ views of pedestrians.

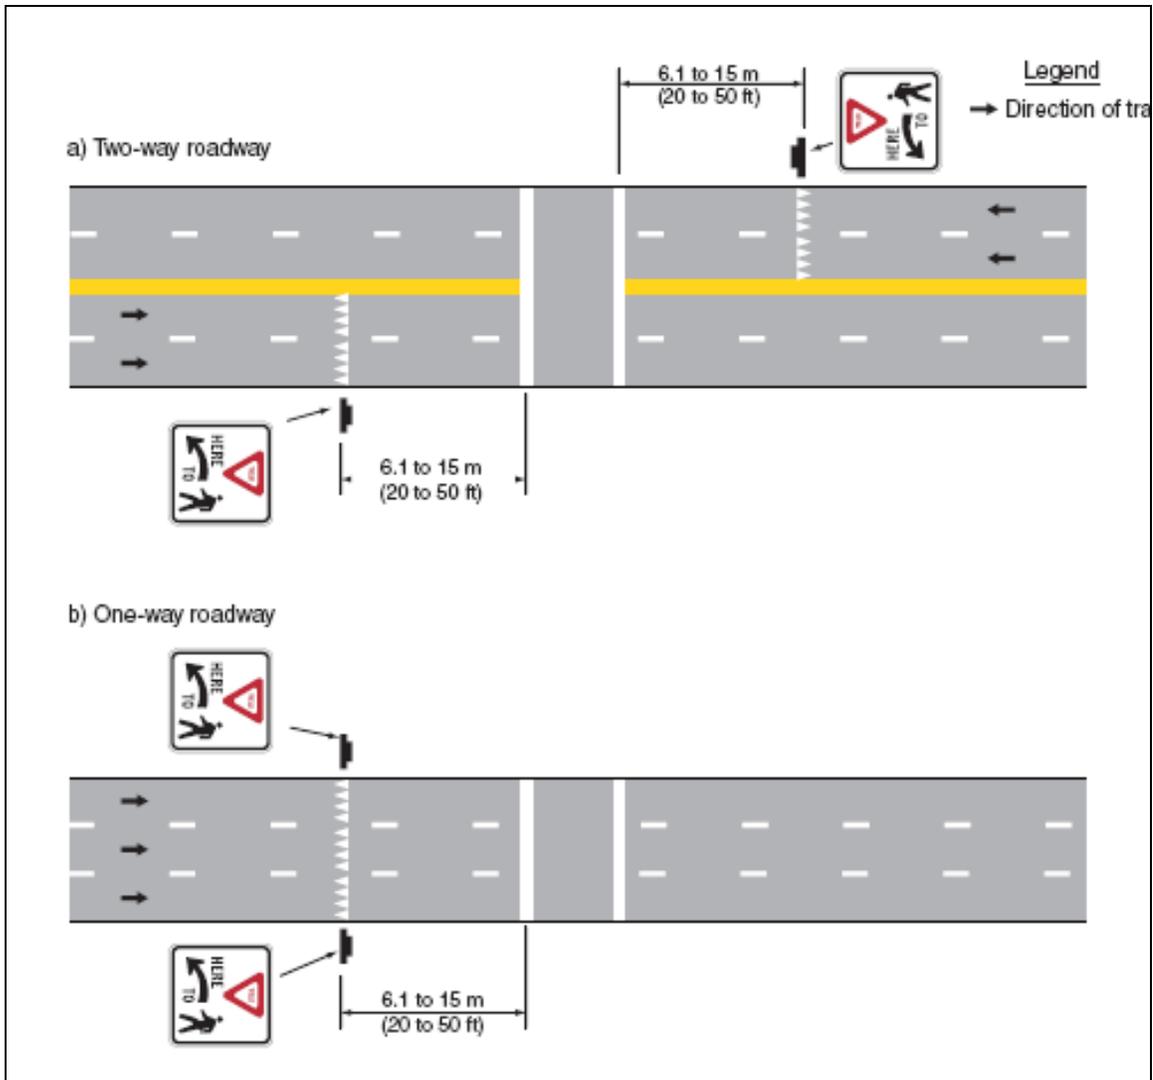
Figure 37 Placement of Yield Markings
 (Source: MUTCD Section 3B)

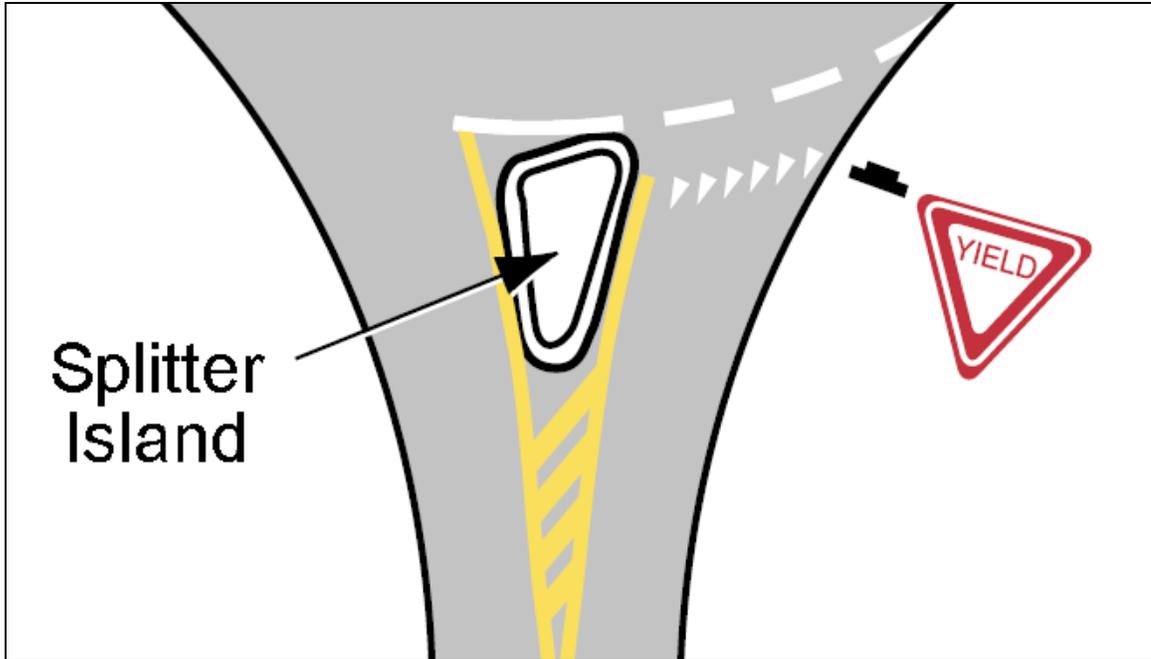
Figure 38 Yield Marking for Roundabout

At roundabout intersections, a yield line (Figure 38) may be used to indicate the point behind which vehicles are required to yield at the entrance to a roundabout intersection.

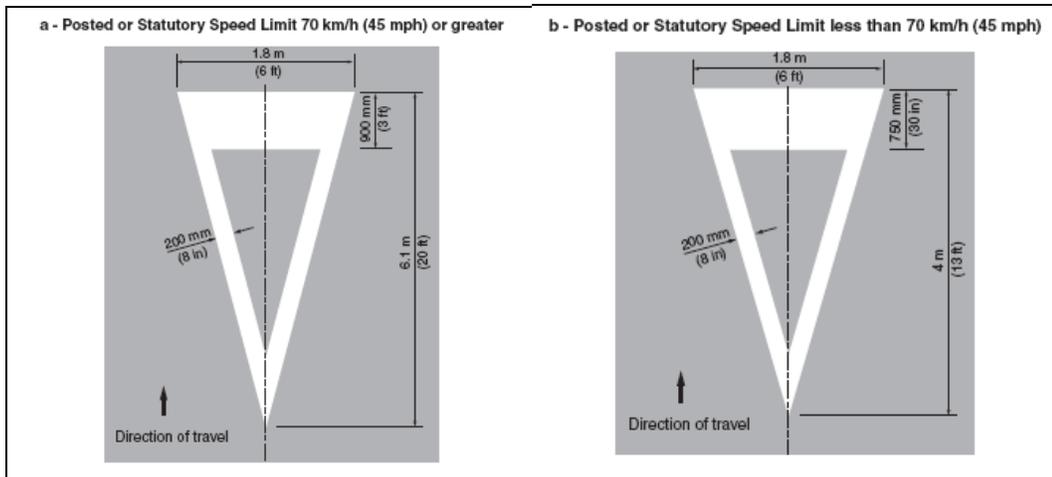
Figure 39 Yield Ahead Triangle

A yield-ahead triangle symbol (Figure 39) or “Yield Ahead” word pavement marking may be used on approaches to intersections where the approaching traffic will encounter a yield sign at the intersection. The yield-ahead triangle symbol or “Yield Ahead” word pavement marking cannot be used unless a yield sign is in place at the intersection. The yield-ahead symbol marking shall be as shown in Figure 39.

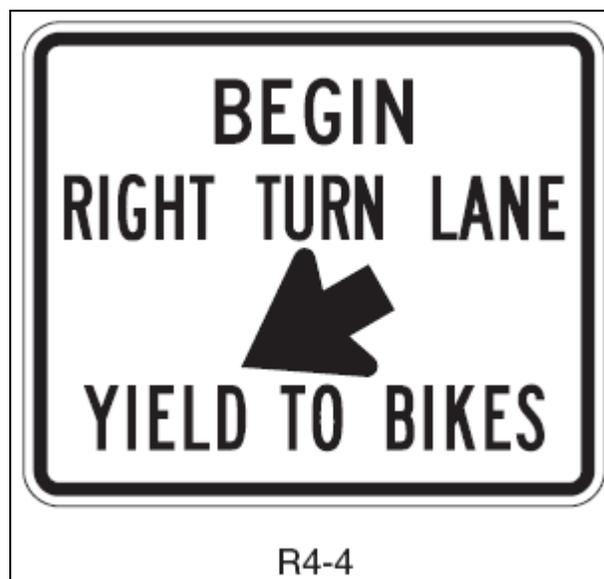
Figure 40 Begin Right Turn Lane Yield to Bikes Sign
(Source: MUTCD)

Other yield signs available are for yielding to bicyclists. The sign is 900 mm by 750 mm. The sign is used where motor vehicles entering an exclusive right-turn lane must weave across bicycle lanes; the “Begin Right Turn Lane Yield to Bikes” (R4-4) sign (Figure 40) may be used to inform both the motorist and the bicyclist of this weaving maneuver.

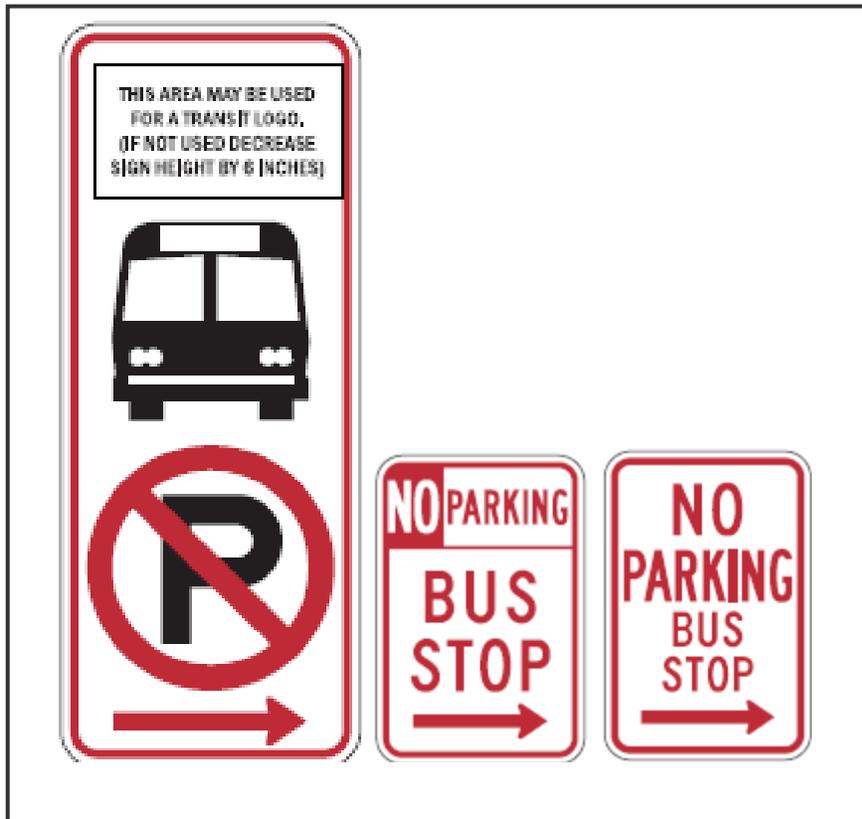
Figure 41 No Parking Signs Related to Transit Stops

parking signs and parking regulations in Section 2B.40 of the MUTCD apply to parking and stopping. Prohibitive signs should have a red legend and border on a white background while permissive signs should have a green legend and border on a white background. Alternate designs may include, on a single panel, a transit logo, an approved bus symbol, the words “Bus Stop”, and an arrow. The preferred bus symbol color is black, but other dark colors may be used. Additionally, the transit logo may be shown on the bus face in the appropriate colors instead of placing the logo separately. The reverse side of the sign may contain bus routing information. Parking prohibition signs around bus stops are illustrated in this section of the MUTCD (Figure 41).

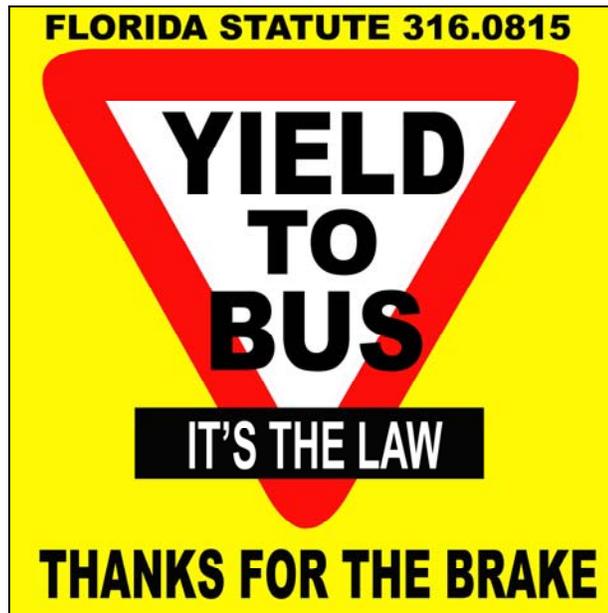
Figure 44 New YTB Decal for StarMetro

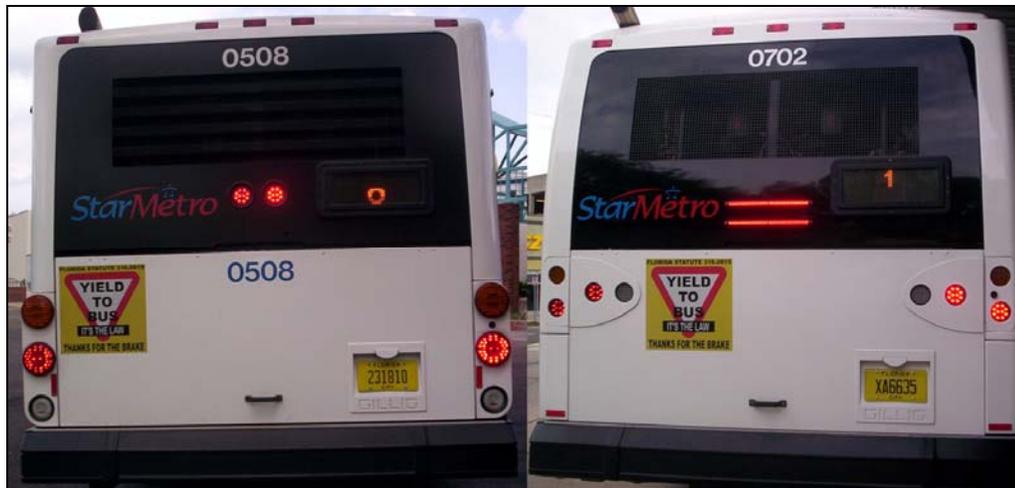
Figure 49 StarMetro Decal Placements

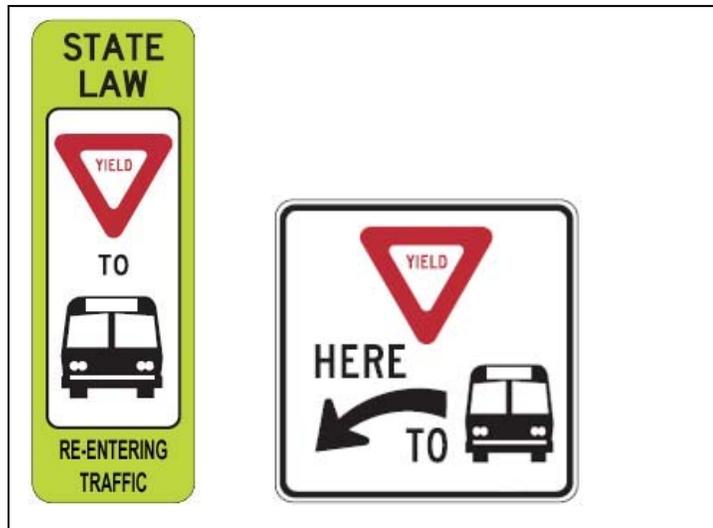
Figure 50 Yield-to-Bus Roadway Signs

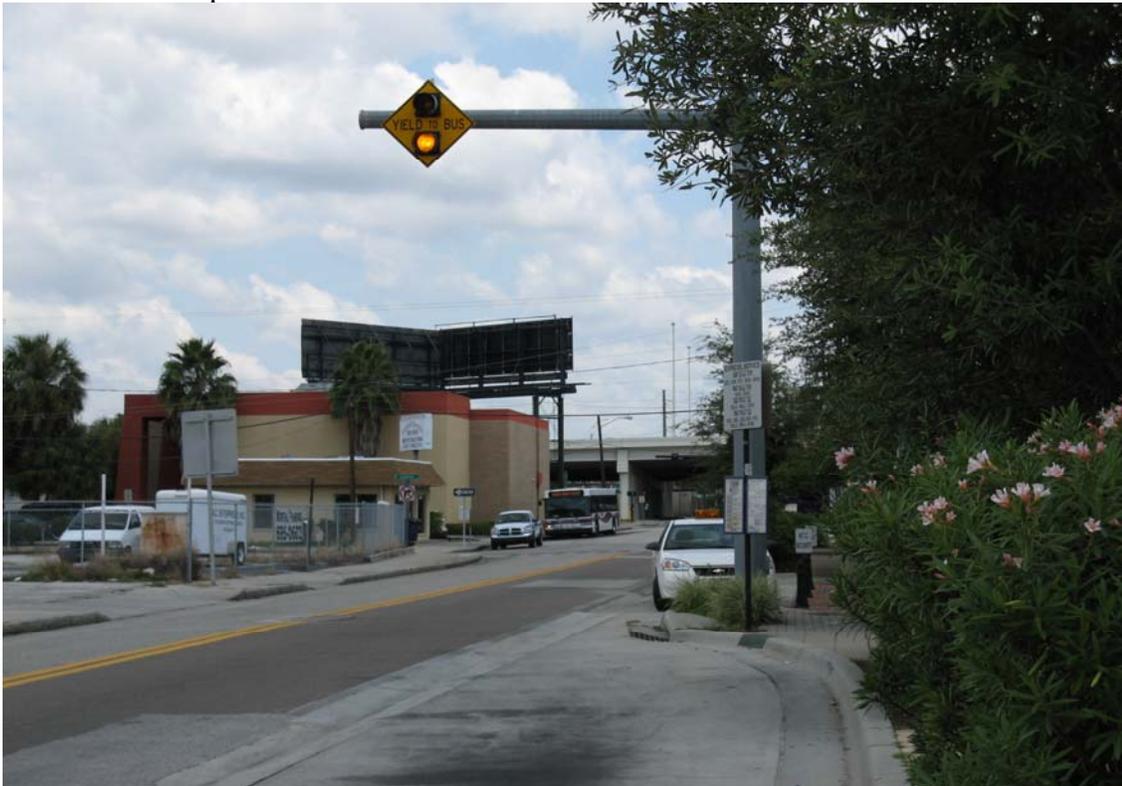
Figure 51 Yield-to-Bus Roadway Flashing Beacons

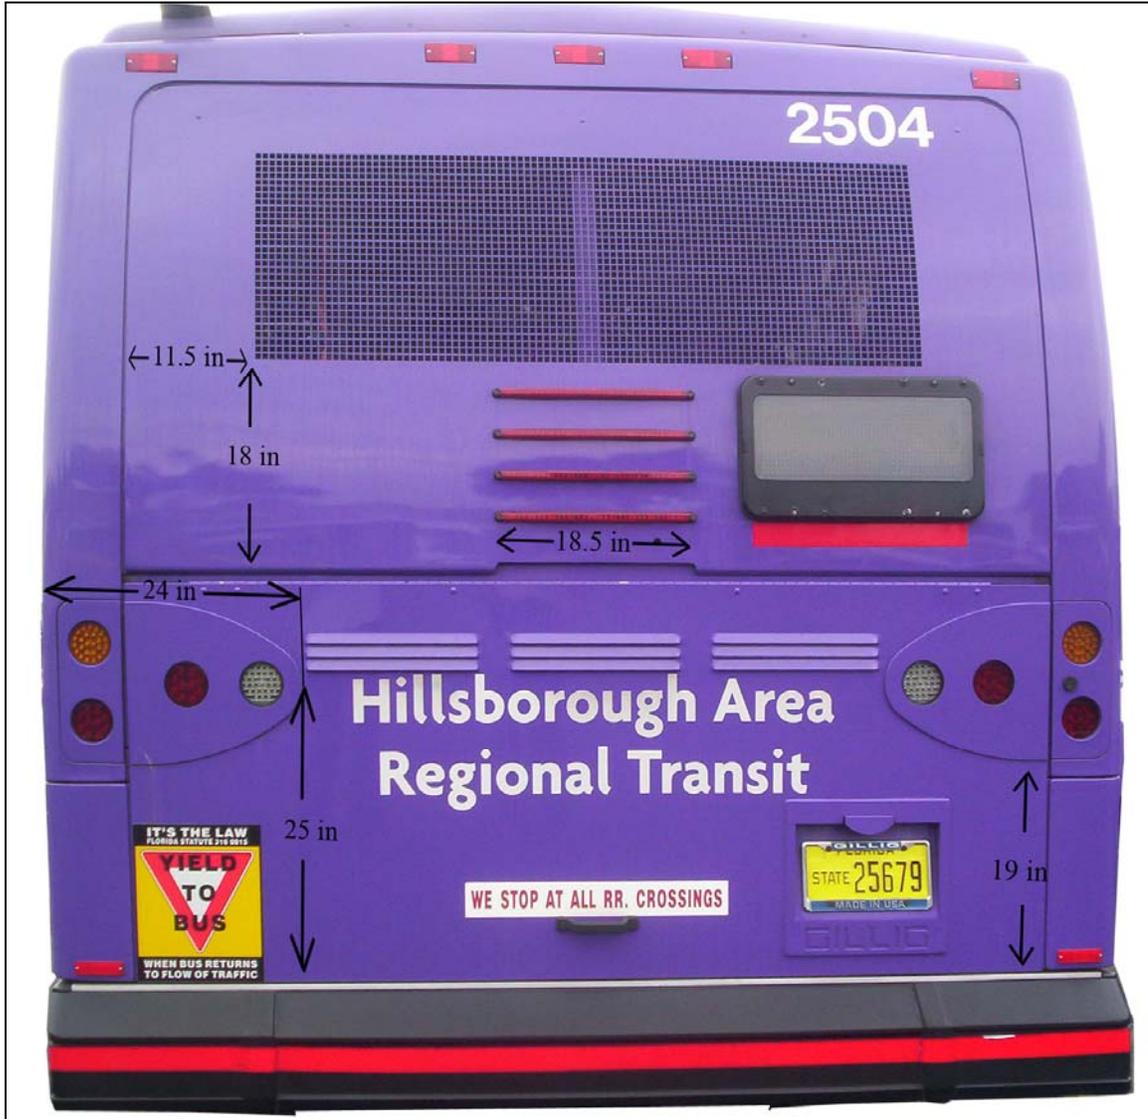
Figure 64 HART Bus with YTB Decal and Dimensions
