Florida's 2004 Hurricane Season

Structural Impacts on the FDOT System

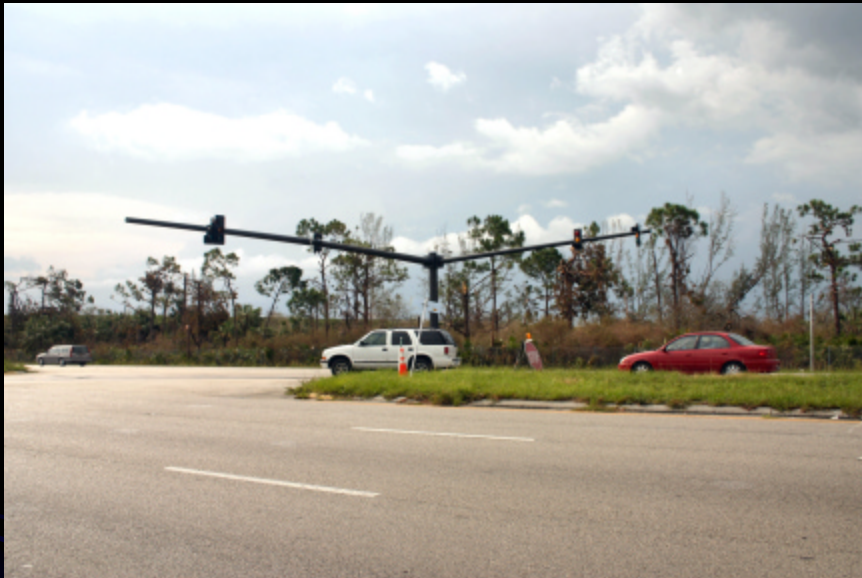
New Mast Arm - Punta Gorda

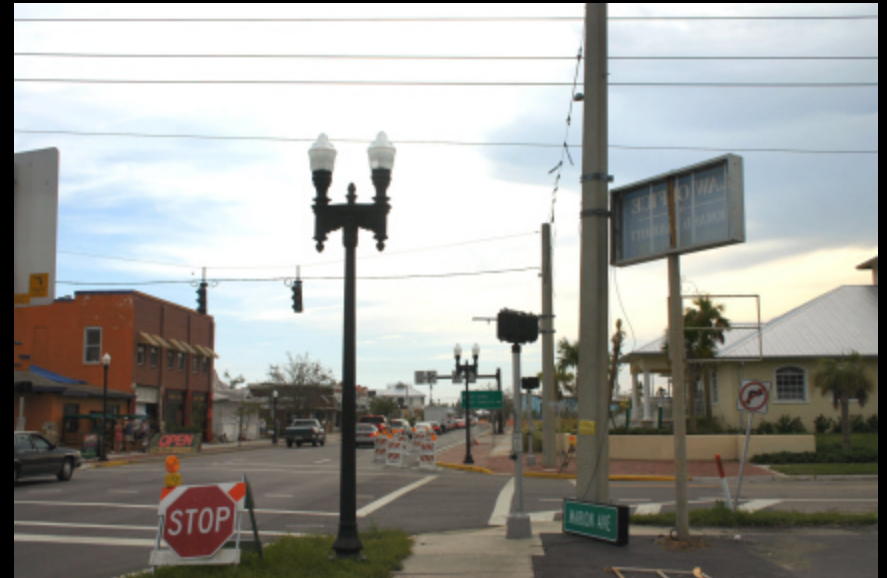
Strain Poles – Punta Gorda

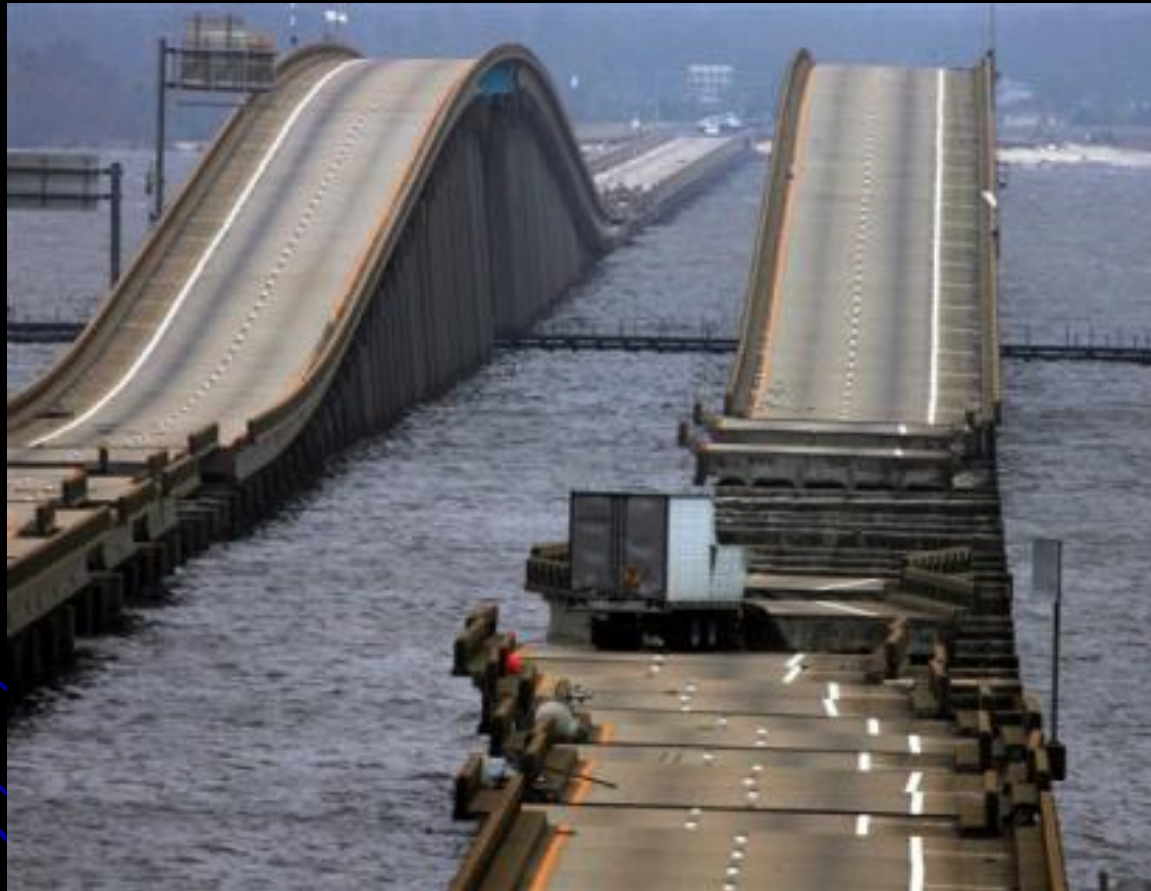
Bridge Looking from West Bank

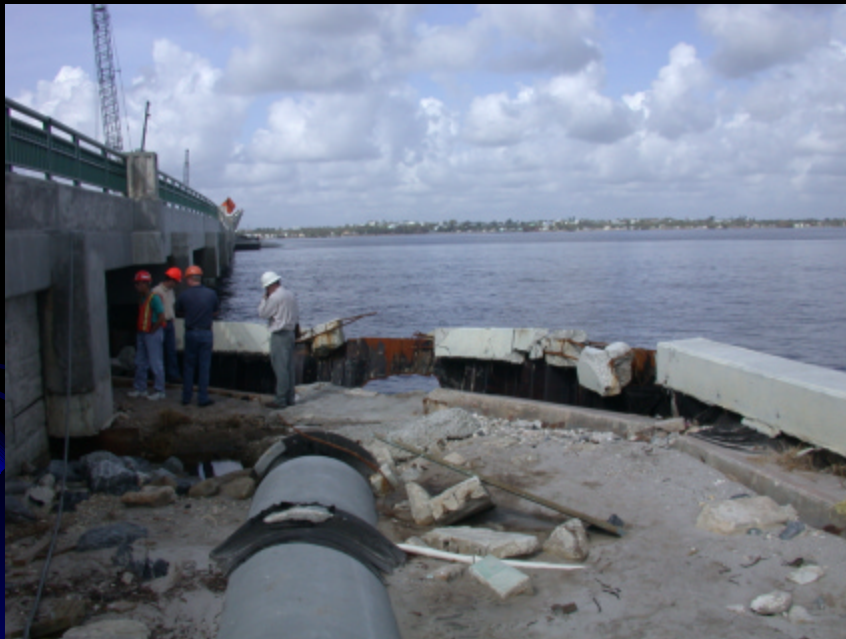
Hurricane Francis

Jensen Beach Causeway – Under Construction
East Relief Bridge

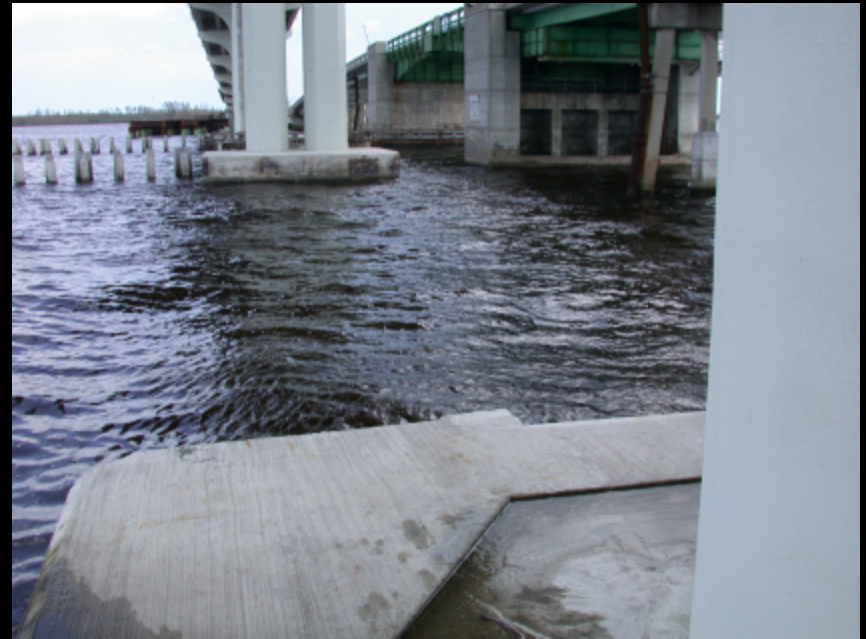
Hurricane Jeanne

Two spans lost – 14" piles shattered

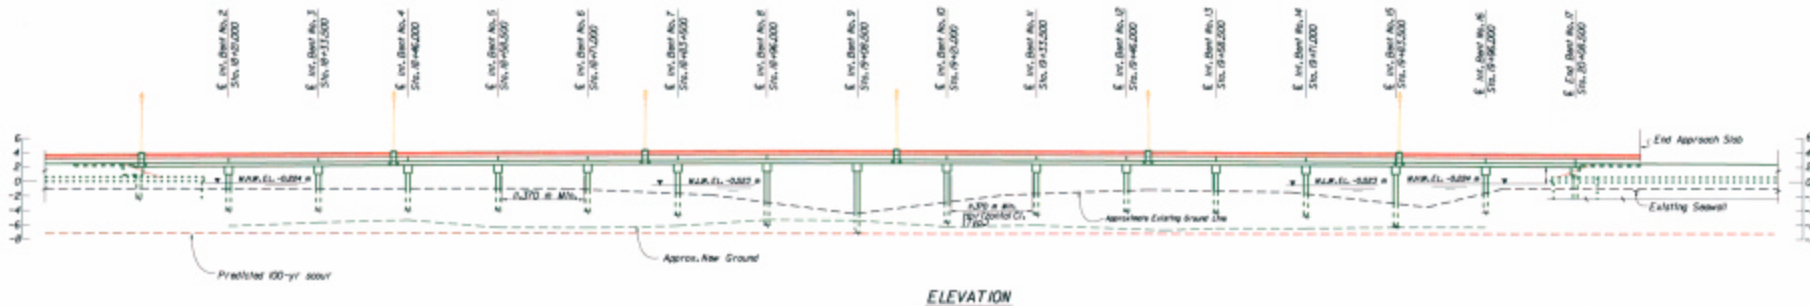
JENSEN BEACH CAUSEWAY

EAST RELIEF BRIDGE AFTER HURRICANES FRANCES AND JEANNE

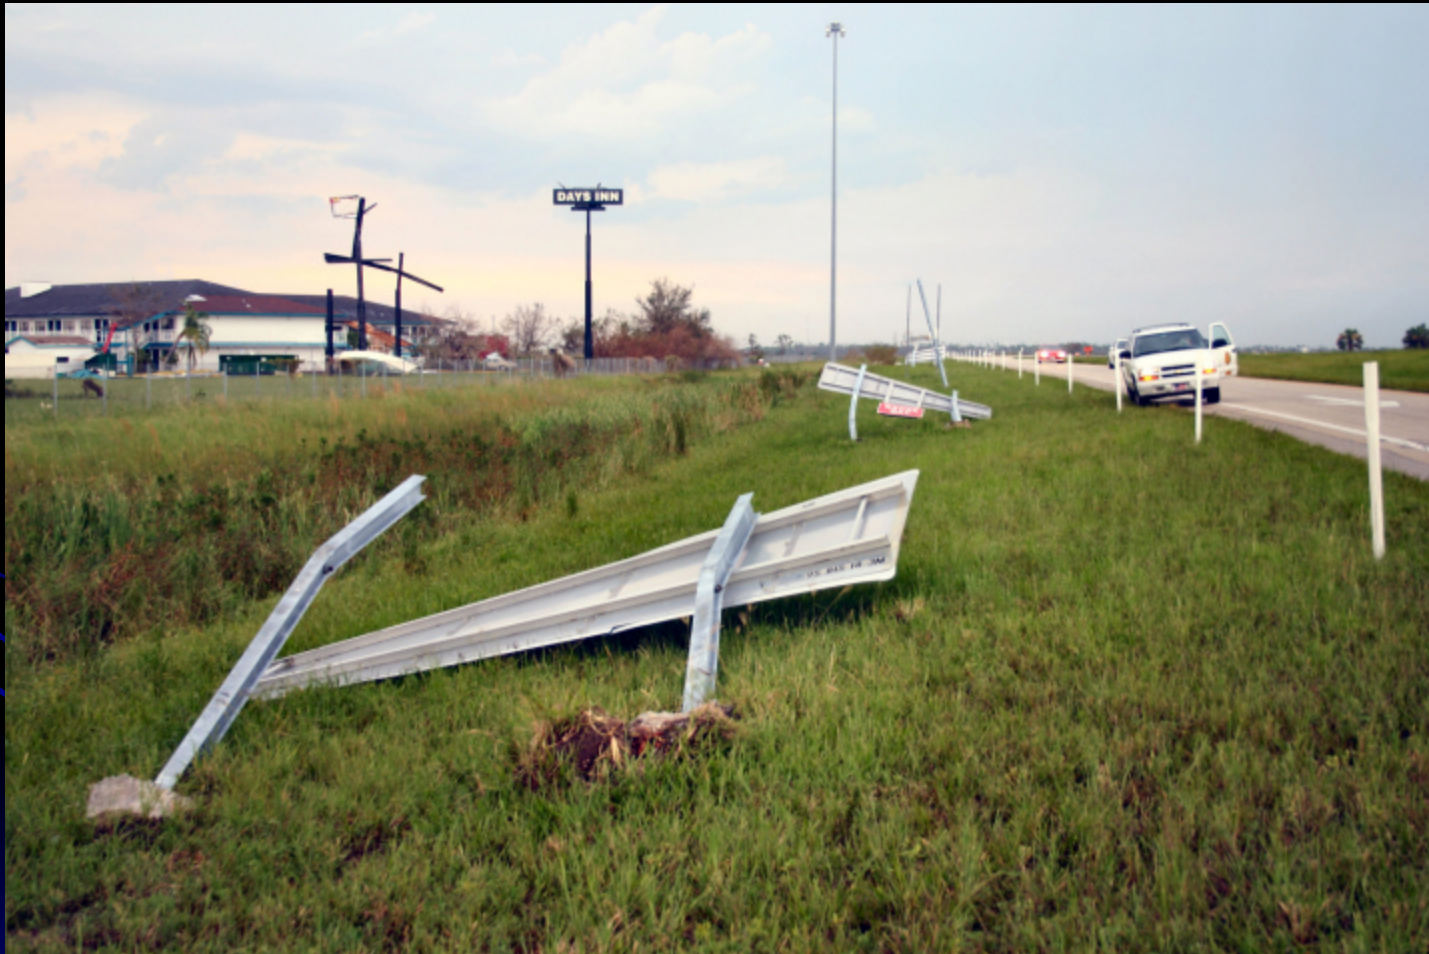
Multi-Post Ground Signs

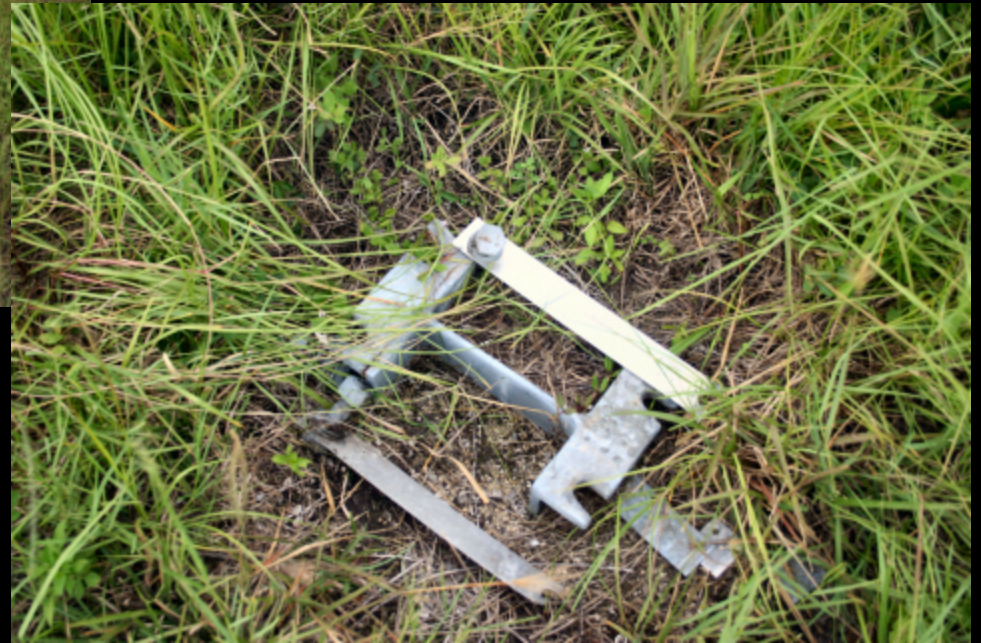
Multi-Post Ground Sign

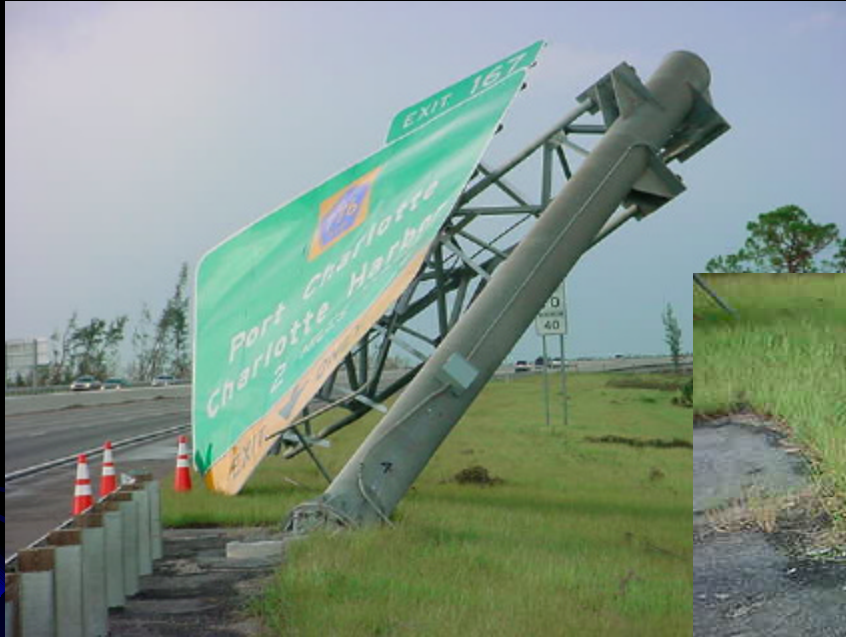
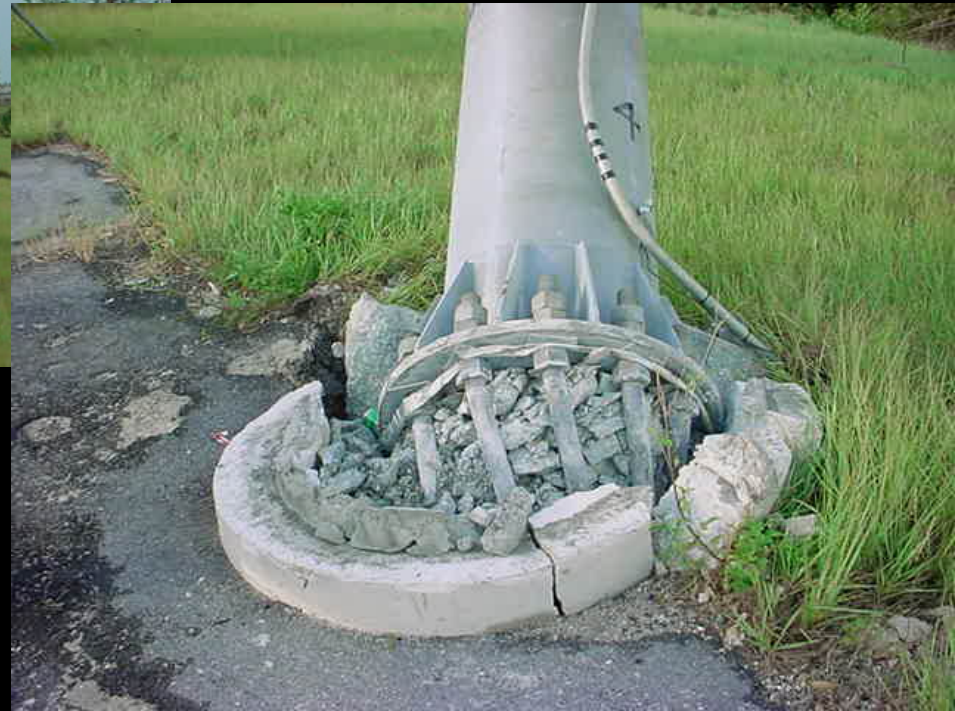
I-75 Cantilever Signs Structure

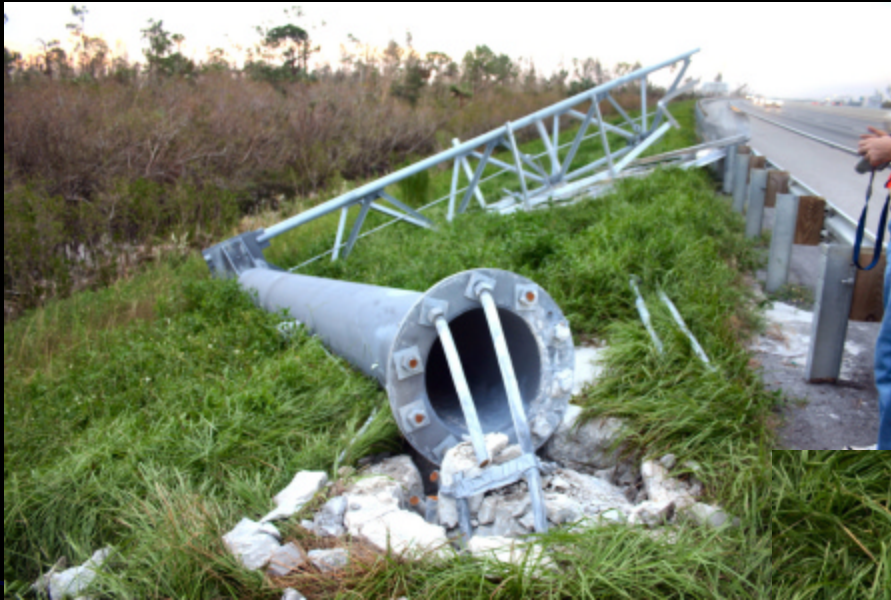
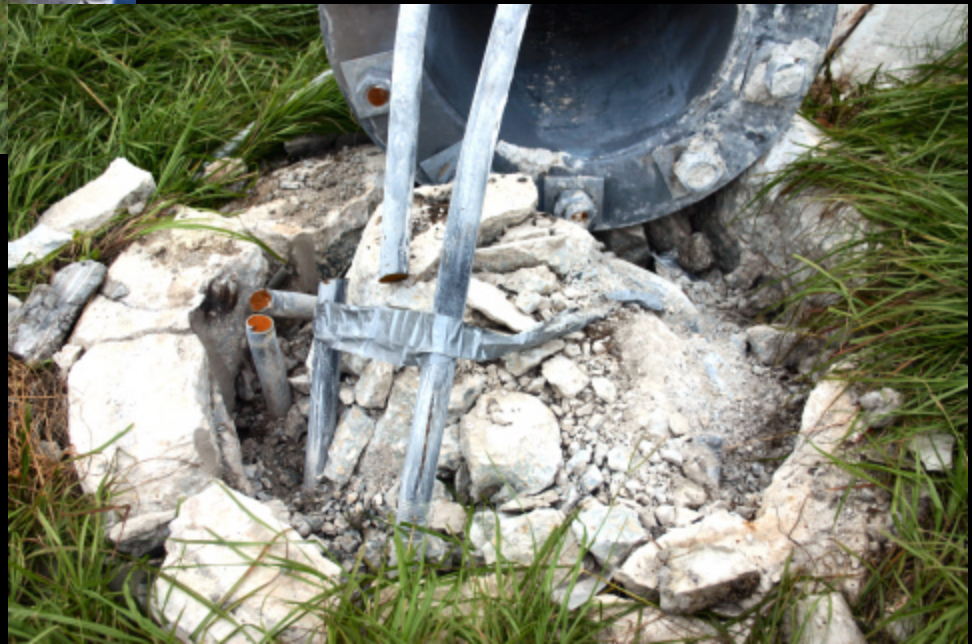
I-75 Cantilever Sign Structure

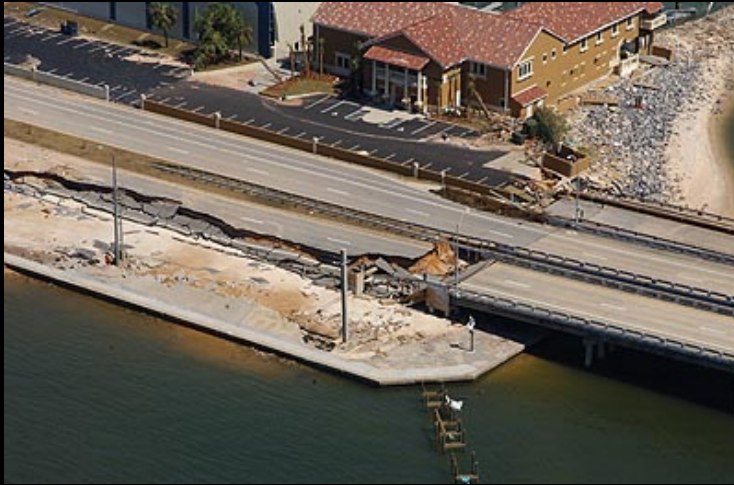
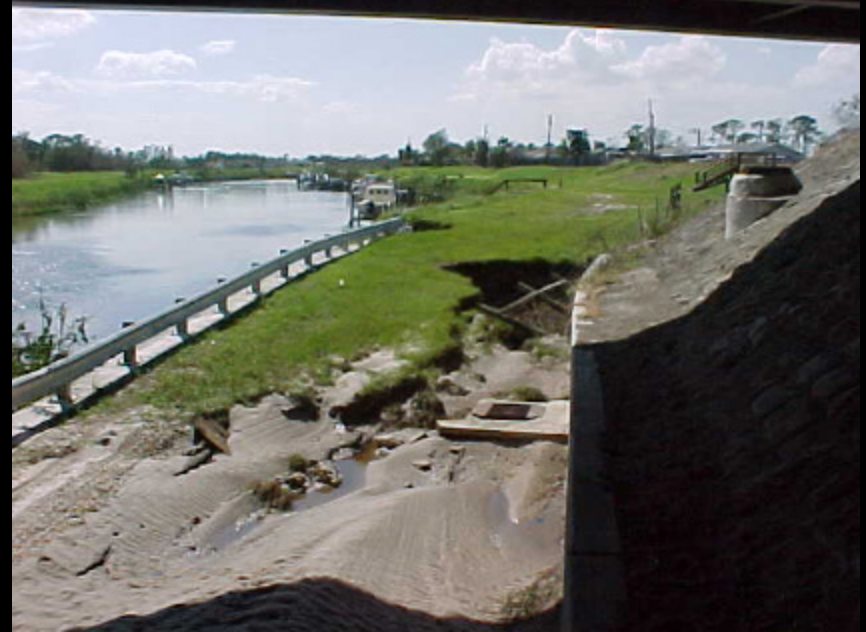
Other Bridges - Erosion
